123 Anywhere Ave Brandon, MS

Magnolia Home Inspections, LLC
108 Cherry Drive
Brandon

Report Number:

001-07-0115

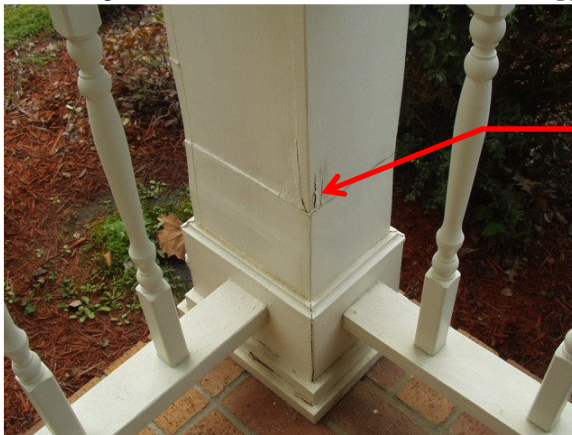
Figure 1: Wood Column on front porch

Evidence of Wood Rot on bottom section of Post

Repair: Recommend contacting Licensed contractor to evaluate visible wood rot and provide estimate of cost and repair.

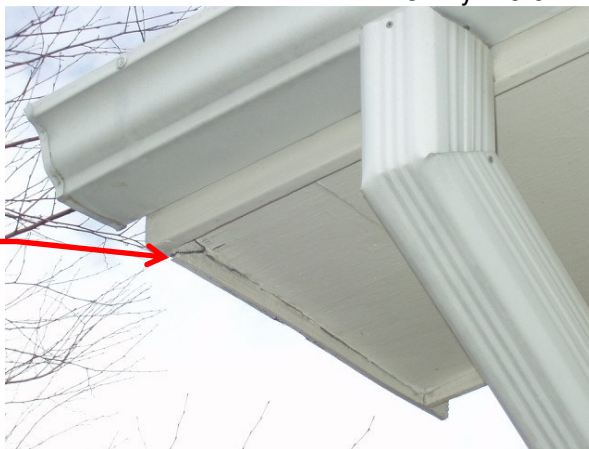
Figure 2: Fascia Board on N.E. Corner of Front Parch

Evidence of wood separation and wood rot on fascia board.

Repair: Fascia board is in need of repair and painting; recommend contacting license contractor for cost estimate and repair
